# Manhole Inspection Summary

Manhole # S23II1038MH

**Location** Address: **1318 MEDFIELD AVE**

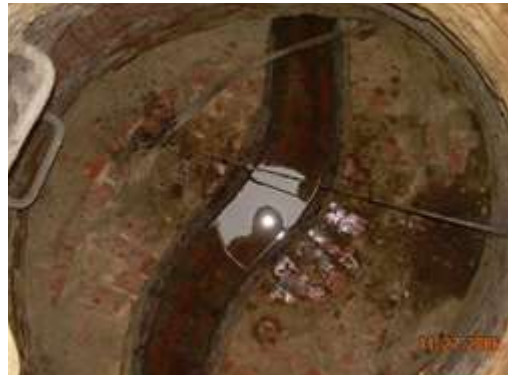
Top View

Bench debris.

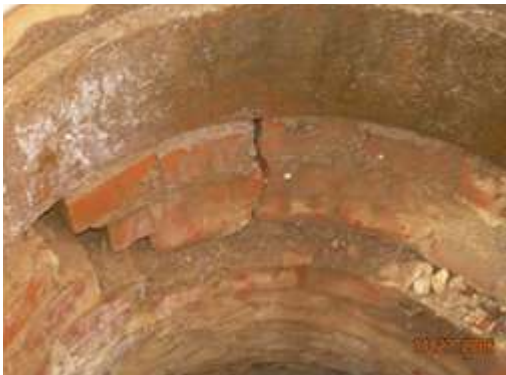
Defect

Condition: ☐ Sound ☐ Cracked ☒ **Leaks**

Condition: ☐ Sound ☒ **Cracked** ☐ Root Intrusion ☒ **Loose Brick** ☒ **Deteriorated**

Infiltration: ☐ None ☒ **Joint** ☒ **Cracks** ☒ **Mortar** ☐ Roots ☐ Wall

Frame leaks. Adjustment deterioration, cracks, loose brick and infiltration - other side.

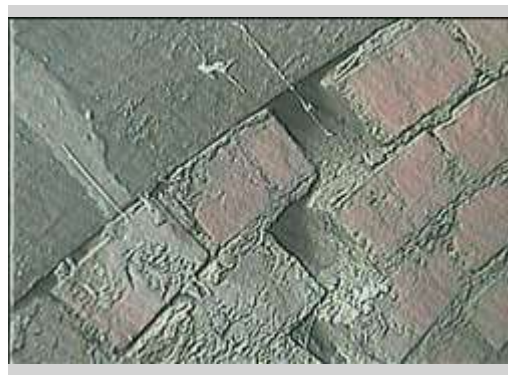
Defect

Frame leaks. Adjustment deterioration, cracks and infiltration.

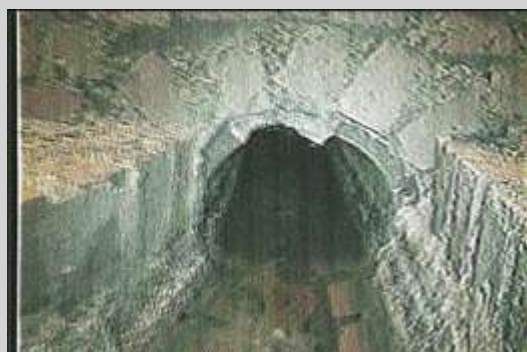
Pipe Out @ 12 O'Clock

Deposits: ☐ None ☐ Mud ☐ Sludge ☐ Debris ☒ **Grease**

Infiltration: **Evidence** Pipe Seal Cond: **Unknown**

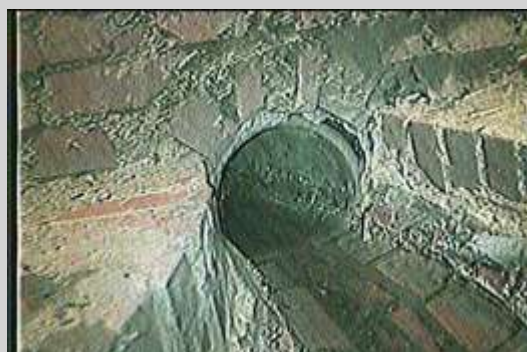
Pipe In @ 7 O'Clock

Condition: ☐ Sound ☐ Cracked ☐ Root Intrusion ☐ Loose Brick ☒ **Deteriorated**

Infiltration: ☐ None ☐ Joint ☐ Cracks ☒ **Mortar** ☐ Roots ☐ Wall

Condition: ☐ Sound ☐ Cracked ☐ Root Intrusion ☒ **Deteriorated** ☐ Leaks ☐ Debris

Barrel deterioration and infiltration. Channel deterioration.
